Design Report

RECREATION IMPROVEMENTS FOR THE VILLAGE OF AUGUSTA
"The Walkable Village - Where the Trails Meet"

ENGR 340
Team 15
5/7/2008

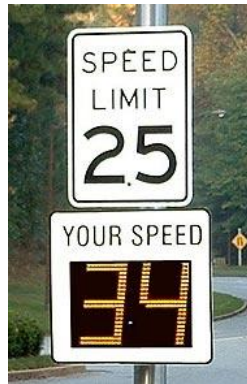
Figure 1: Digital Radar Speed Feedback Sign

Digital and radar combined speed signs consist of a traditional pole mounted speed limit sign with a computer box mounted below. The computer box contains a radar speed detector, a hard drive, and an LED screen. The sign records the speed of oncoming vehicles and is able to display that speed to drivers as they pass. These are considered effective with drivers who do not realize they are speeding because the posted speed is below the speed allowed by visibility and pavement conditions. The computer box is capable of recording data for extended periods of time, allowing for studies of the effectiveness of the sign and for studies of daily and seasonal traffic patterns. Many models of these signs include solar panels to decrease the maintenance required.

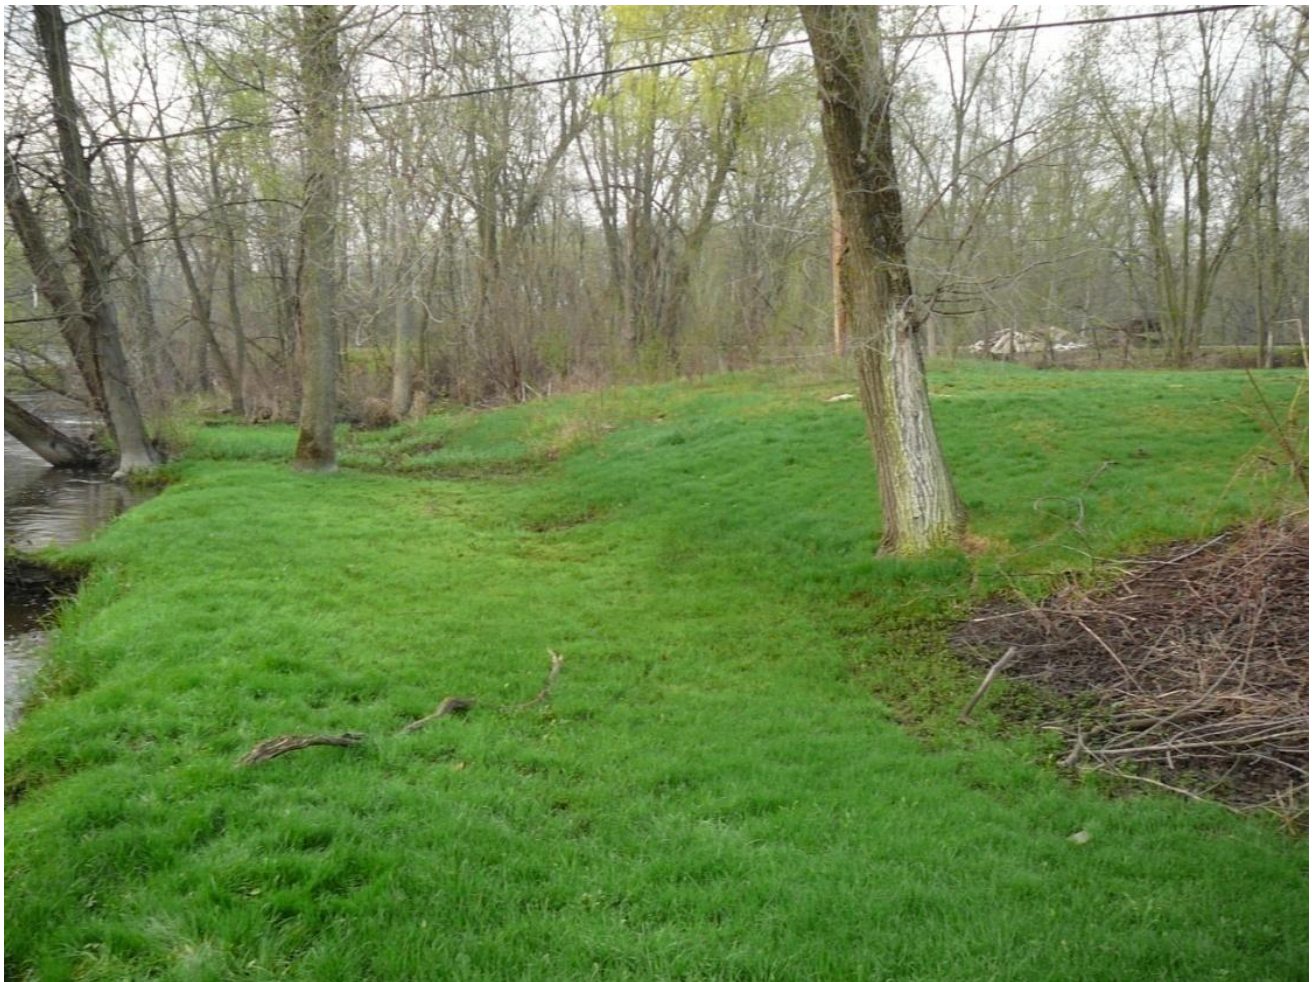
Figure 2 Proposed Landing Location

In consideration of the options available, we recommend a signed, ADA compliant asphalt boat launch that can provide easy access for canoes and kayaks, to be located on the south side of the Kalamazoo River Bridge, with parking and access through Players Sports Bar and Grill as can be negotiated. The openness of the site will be easy for visitors to notice the boat launch, and deter vandalism and crime. Shared parking with Players Sports Bar will allow boaters who park in Augusta to make use of the existing parking lot, and the sight of the restaurant will welcome river travelers and encourage them to stop in Augusta. Ideally, Players Sports Bar will also be able to benefit from this new flow of visitors.

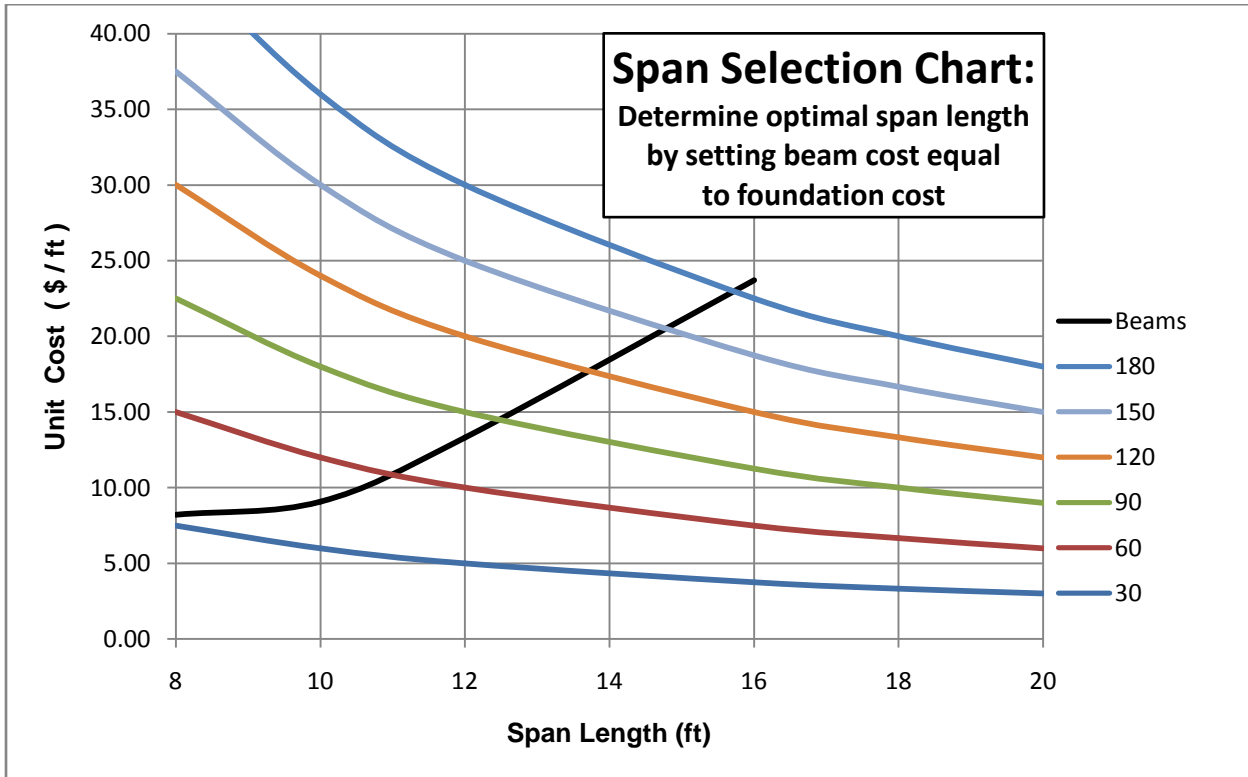
Figure 3 Span Selection Chart

To optimize the design of the boardwalk span and minimize cost, a span length should be selected such that the foundation costs and the beam costs are roughly equal. Decreasing the span length from this optimal point will decrease the number or size of beams; however, more foundations will be necessary and the overall cost will increase. The accompanying span selection chart is included to aid in this decision process.

Boardwalk spans were designed in accordance with American Wood Council’s *LRFD Manual for Engineered Wood Construction*, with reference to International Codes Council’s *Design of Wood Structures* textbook. After working through a sample calculation by hand, the equations were programmed into a spreadsheet to determine the necessary beam size for a variety of span lengths. The spreadsheet then relates these beams sizes to a cost, determined by a table of lumber prices tabulated from the local Home Depot’s website. A plot of unit cost per span length can be found in Figure 3.

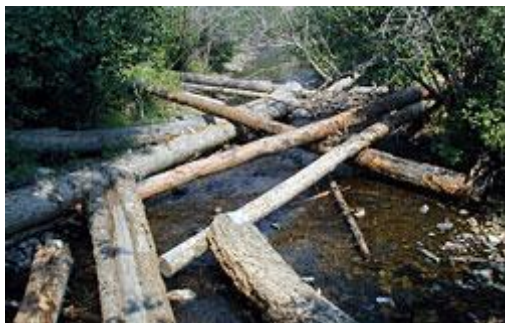
Figure 8 – Logs Used as Cover (montanatroutrout.org)

Several similar projects use obstructions such as rocks and logs for shade and to direct flow. It does not appear that a hydraulic analysis was necessary in any of these cases. The solutions are reached by biologists and geologists with little engineering work. Figure 8 from montanatroutrout.org shows an example of this type of project where logs are used to provide shade and direct the flow of water. Figure 9 from the US fish and wildlife service shows an example of rocks being used in both a before and an after picture.

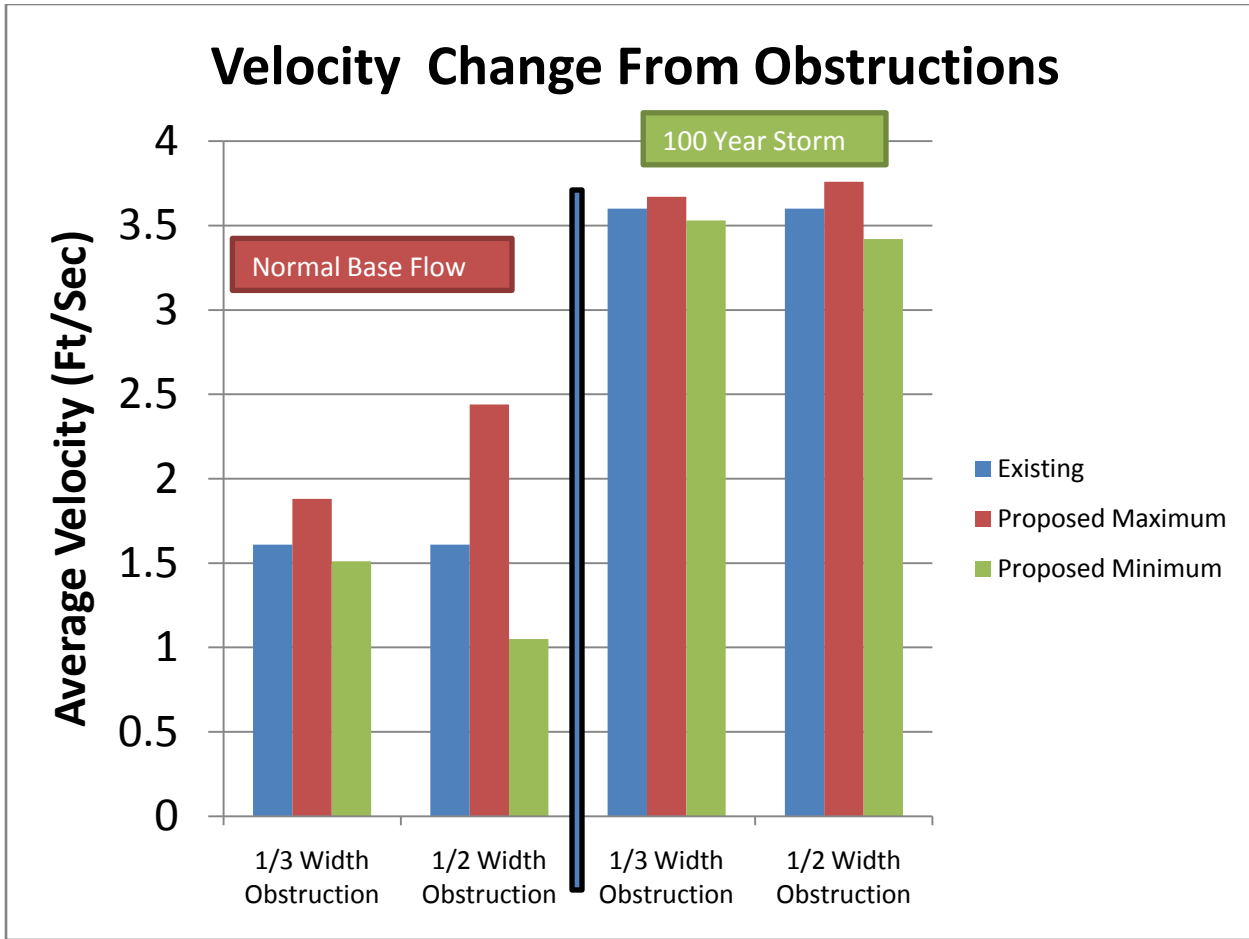
Figure 14 – Velocity Change from Obstructions

Figure 14 shows the average velocities in the channel during both a 100 year storm event and the average base flow that we are designing the obstructions for. During the low flow condition the obstructions increase the average velocity by reducing the cross sectional area. They also reduce the velocity between them by increasing the water level and thus the flow area. This change in velocity is what is desired for the trout. During the flooding event the water level rises above the obstructions and they have a much smaller affect on the velocities.
